CIRCULAR OF THE BUREAU OF STANDARDS C450

UNDERGROUND CORROSION

By Kirk H. Logan

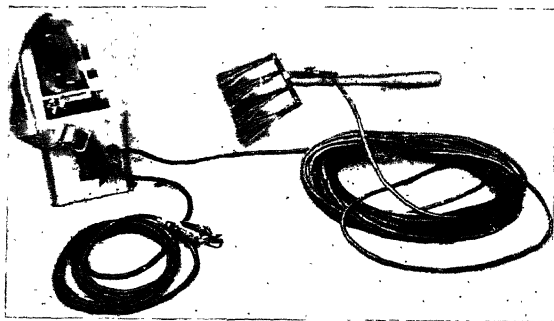
FIGURE 72.—Apparatus for locating pinholes in bituminous coatings. It consists of a Ford spark coil, dry batteries, and a metal brush with an insulated handle.

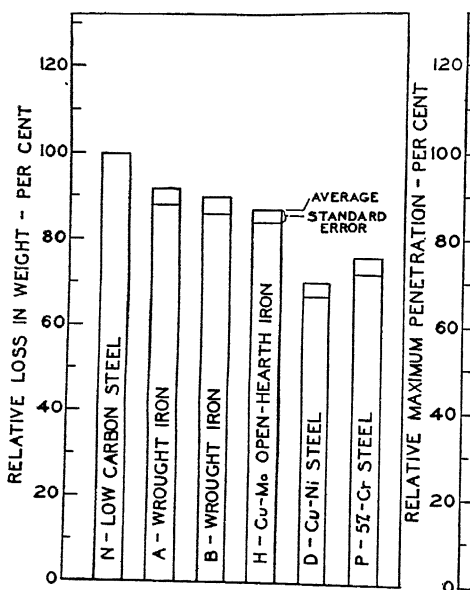
FIGURE 74.—Relative loss of weight and penetration of wrought ferrous specimens. Low carbon steel=100 percent.

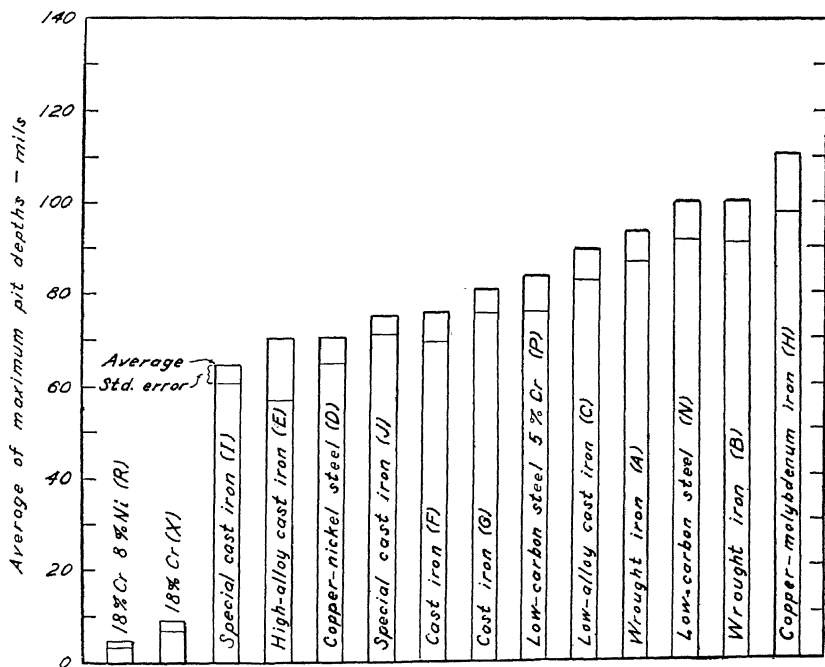
FIGURE 75.—Average of maximum pit depths on ferrous pipes removed from Merced clay adobe after an exposure of 5 years.

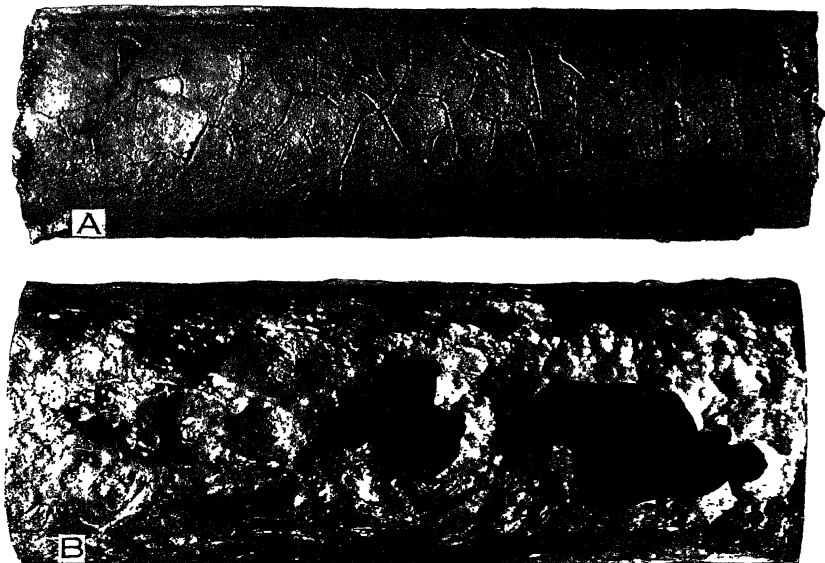
FIGURE 76.—Examples of failure of pipe coatings.

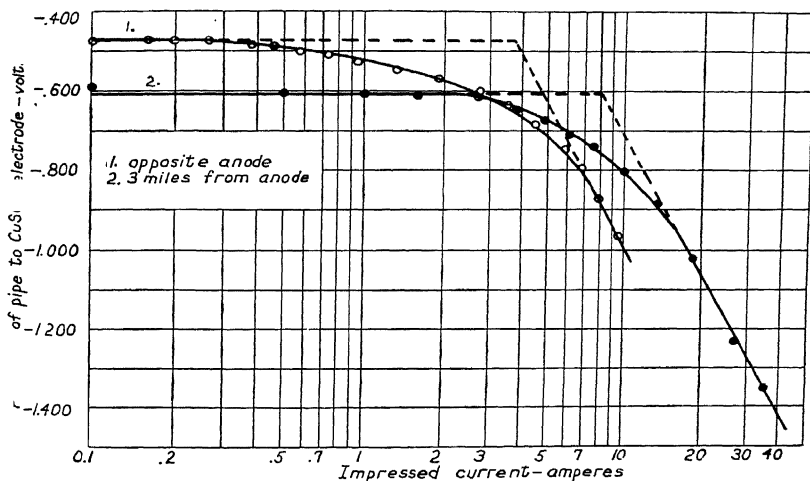
FIGURE 77.—Current-potential curves for 6-inch pipe.

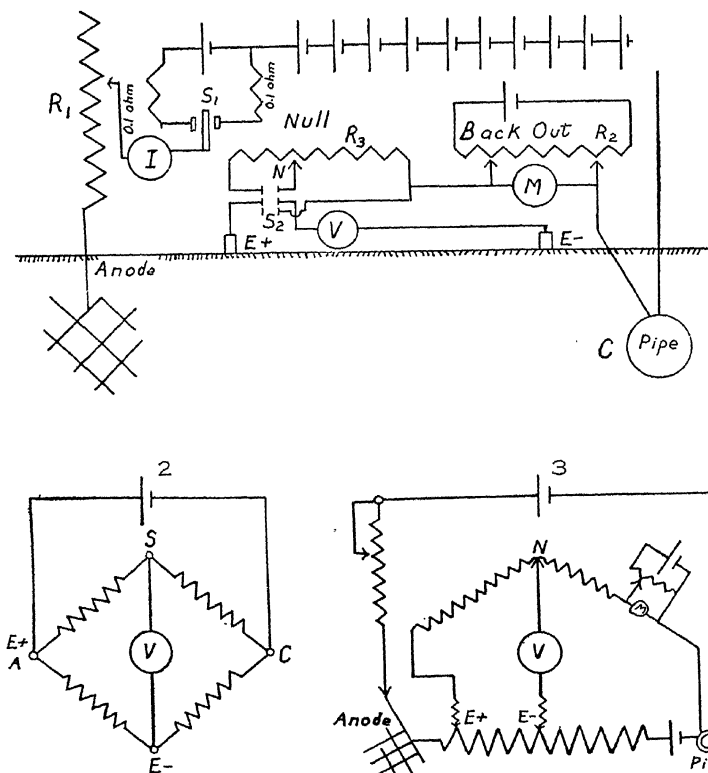
FIGURE 78.—Pearson-Hadley null current.
1, Null circuit; 2, wheatstone bridge current for comparison with 3, the testing circuit in 1. The letters designate corresponding parts in each circuit.

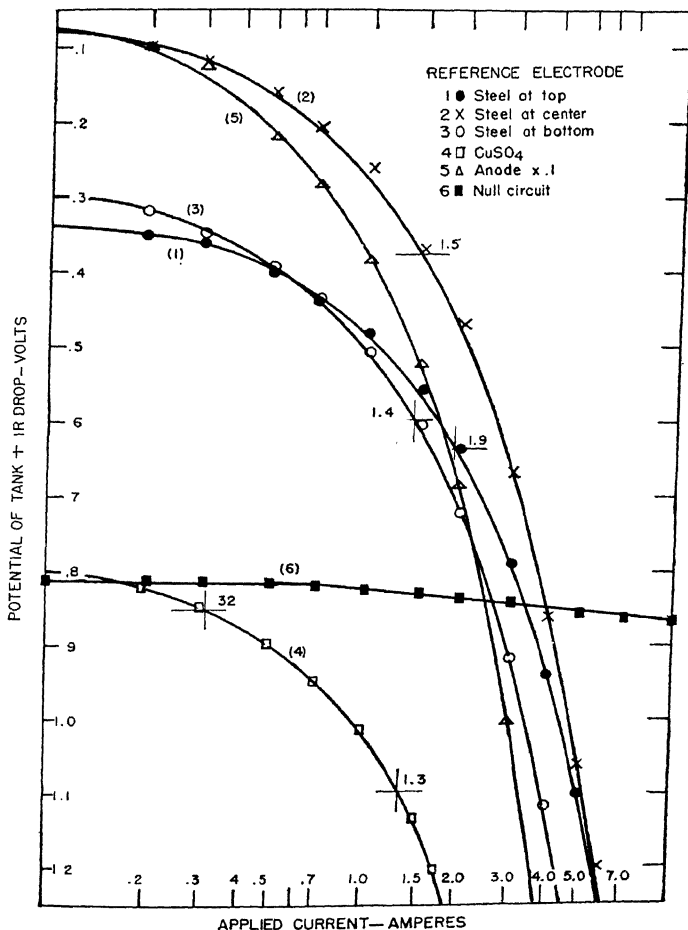
FIGURE 79.—Current-potential curves for a buried tank.

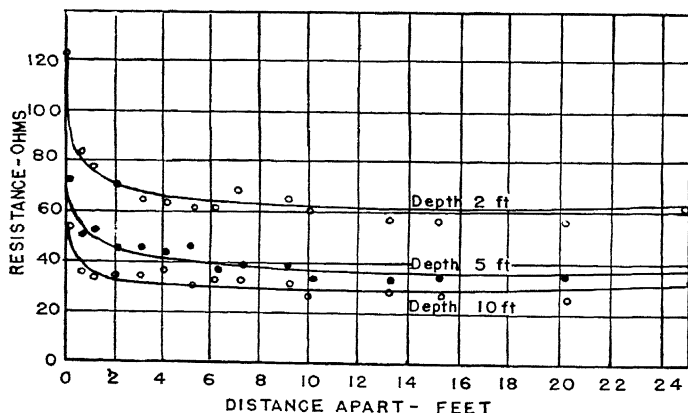
FIGURE 83.—Effect of the distance apart of two driven-pipe grounds in parallel on their resistance to earth.

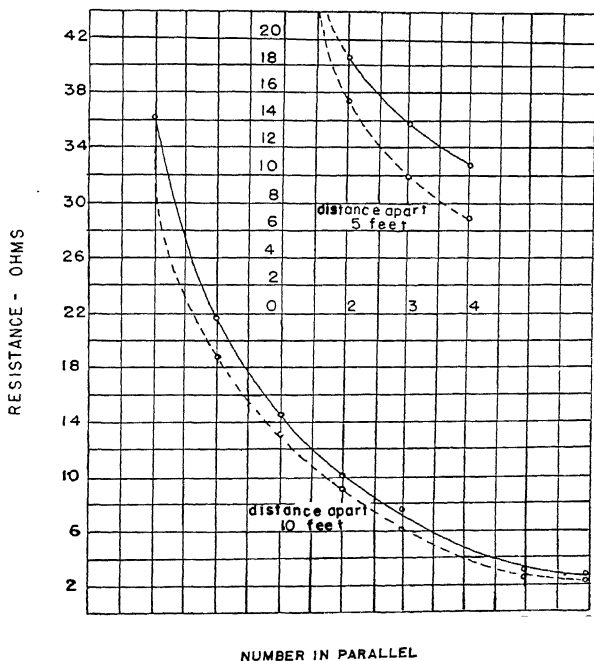
FIGURE 84.—Effect of the number of 10-foot driven-pipe grounds in parallel on their resistance to earth.

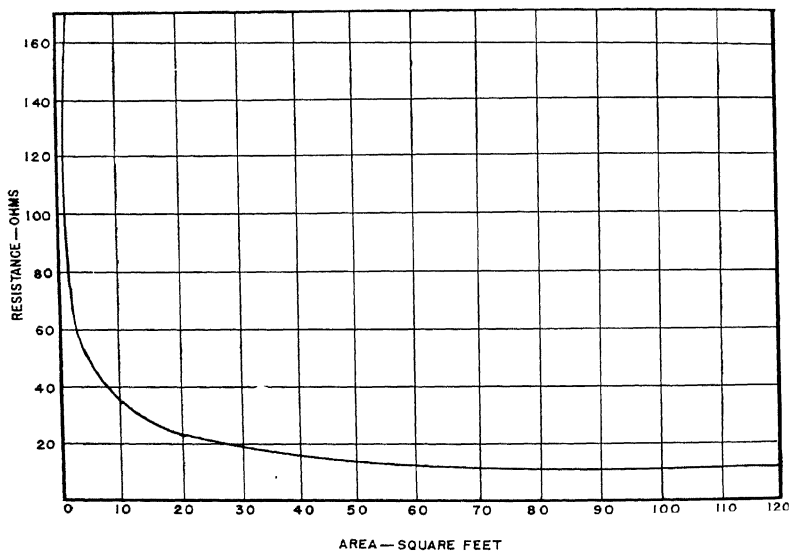
FIGURE 85.—Effect of the diameter of a buried circular plate on its resistance to ground.

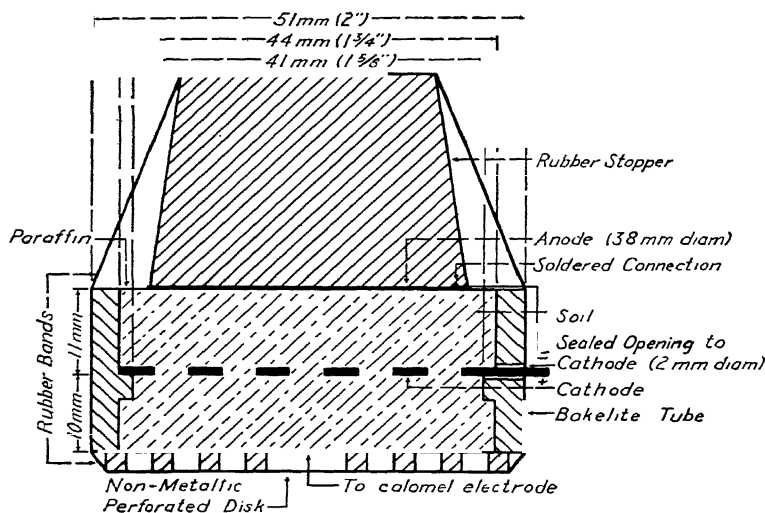
FIGURE 87.—Denison corrosion cell.
